# Severn Estuary Forum 2017

## David Martin and Lucy George

### Wessex Water

## Bathing Water improvements

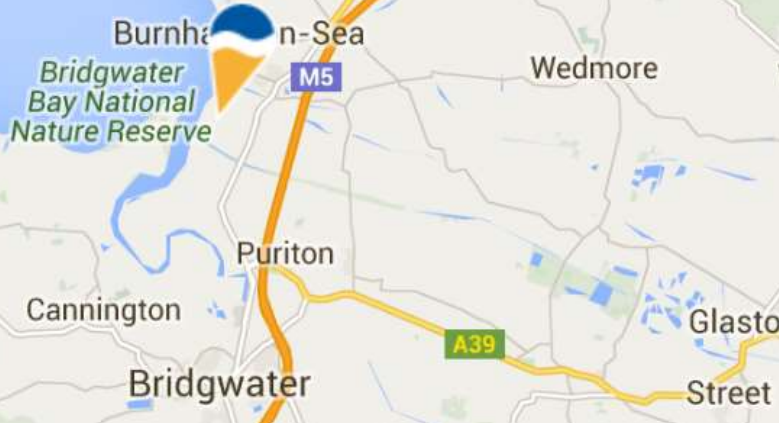
## Burnham Jetty

☑ Quality status 2016:Fail

There has not been a spill in the last 24 hours

This bathing water can be affected by spills during storms or incidents

5/7	4/7	3/7	2/7	1/7	30/6	29/6
No	No	No	No	No	No	No

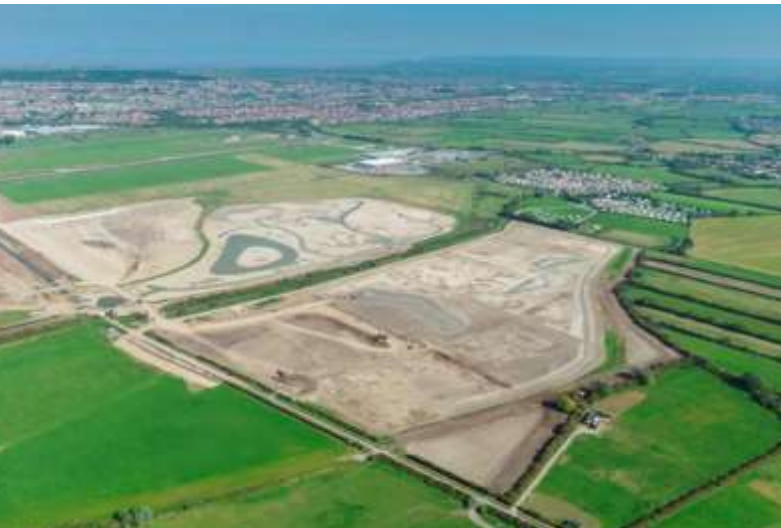
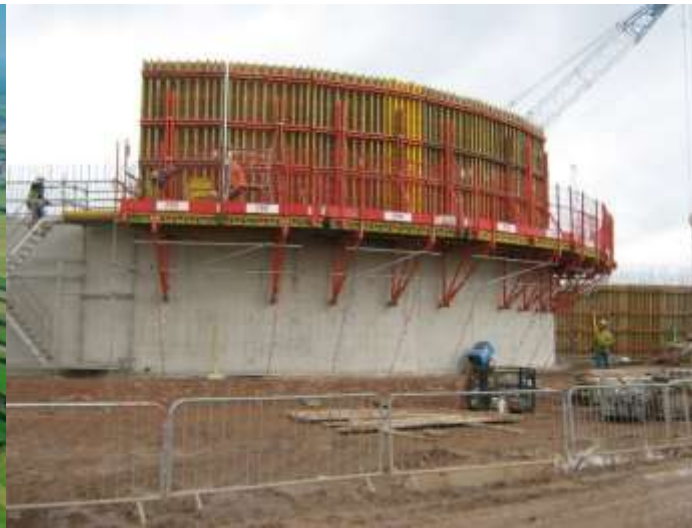
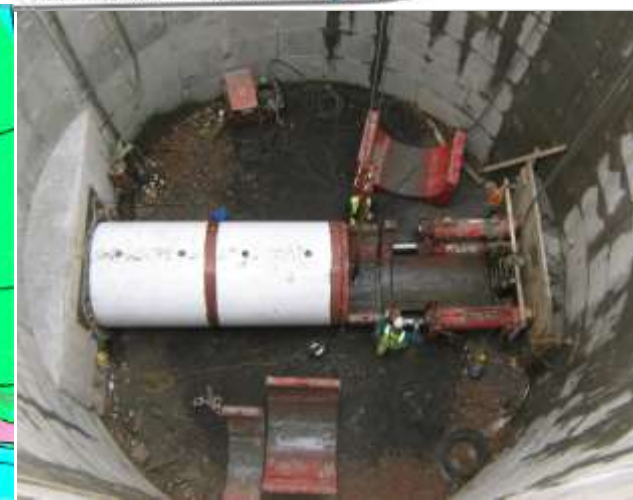
# Weston-super-Mare bathing water improvements

- £30m, completed 2015
- More Aeration lanes
- More Final settlement tanks
- New Tertiary treatment (UV)
- 21,000 m<sup>3</sup> storage
- Superpond partnership scheme

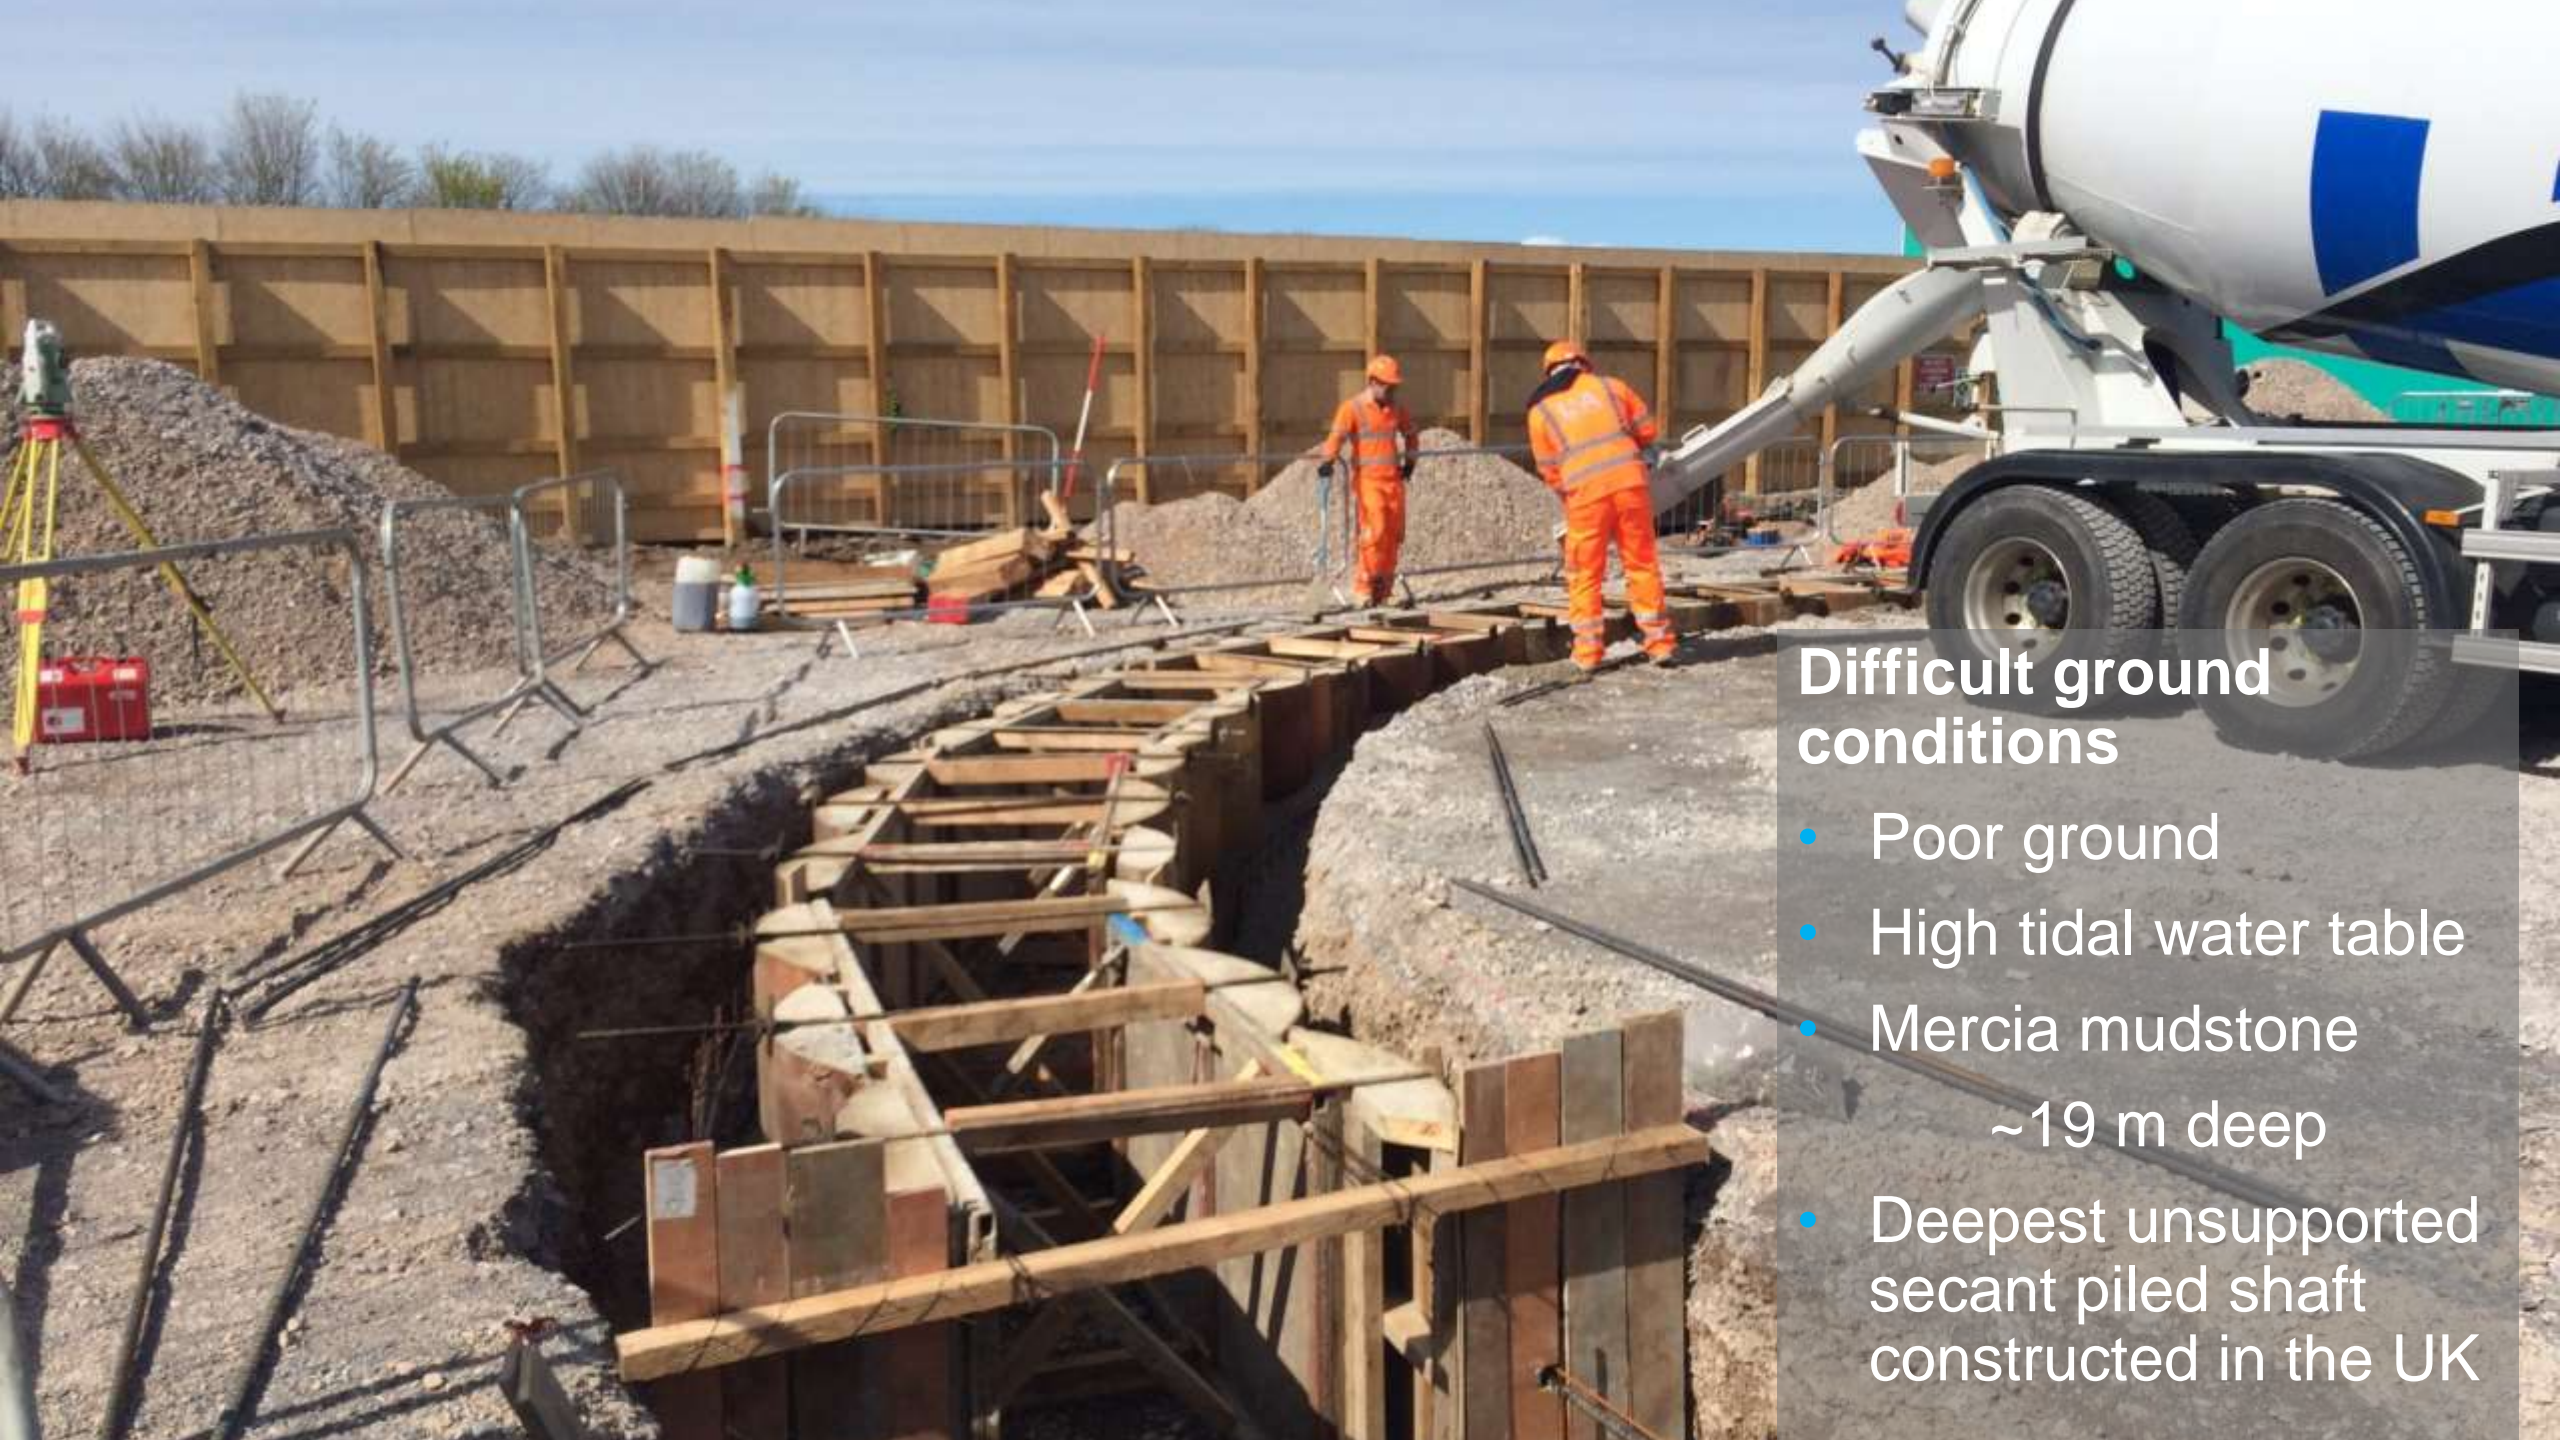
## Bristol Road, Bridgwater Sewage Pumping Station

- Tight site
  - A38
  - River flood bund
  - Residential and business property
- 3000 m<sup>3</sup> storage
- Shaft – 15 m diameter and 23 m deep
- Innovative design
- 165 l/s to treatment

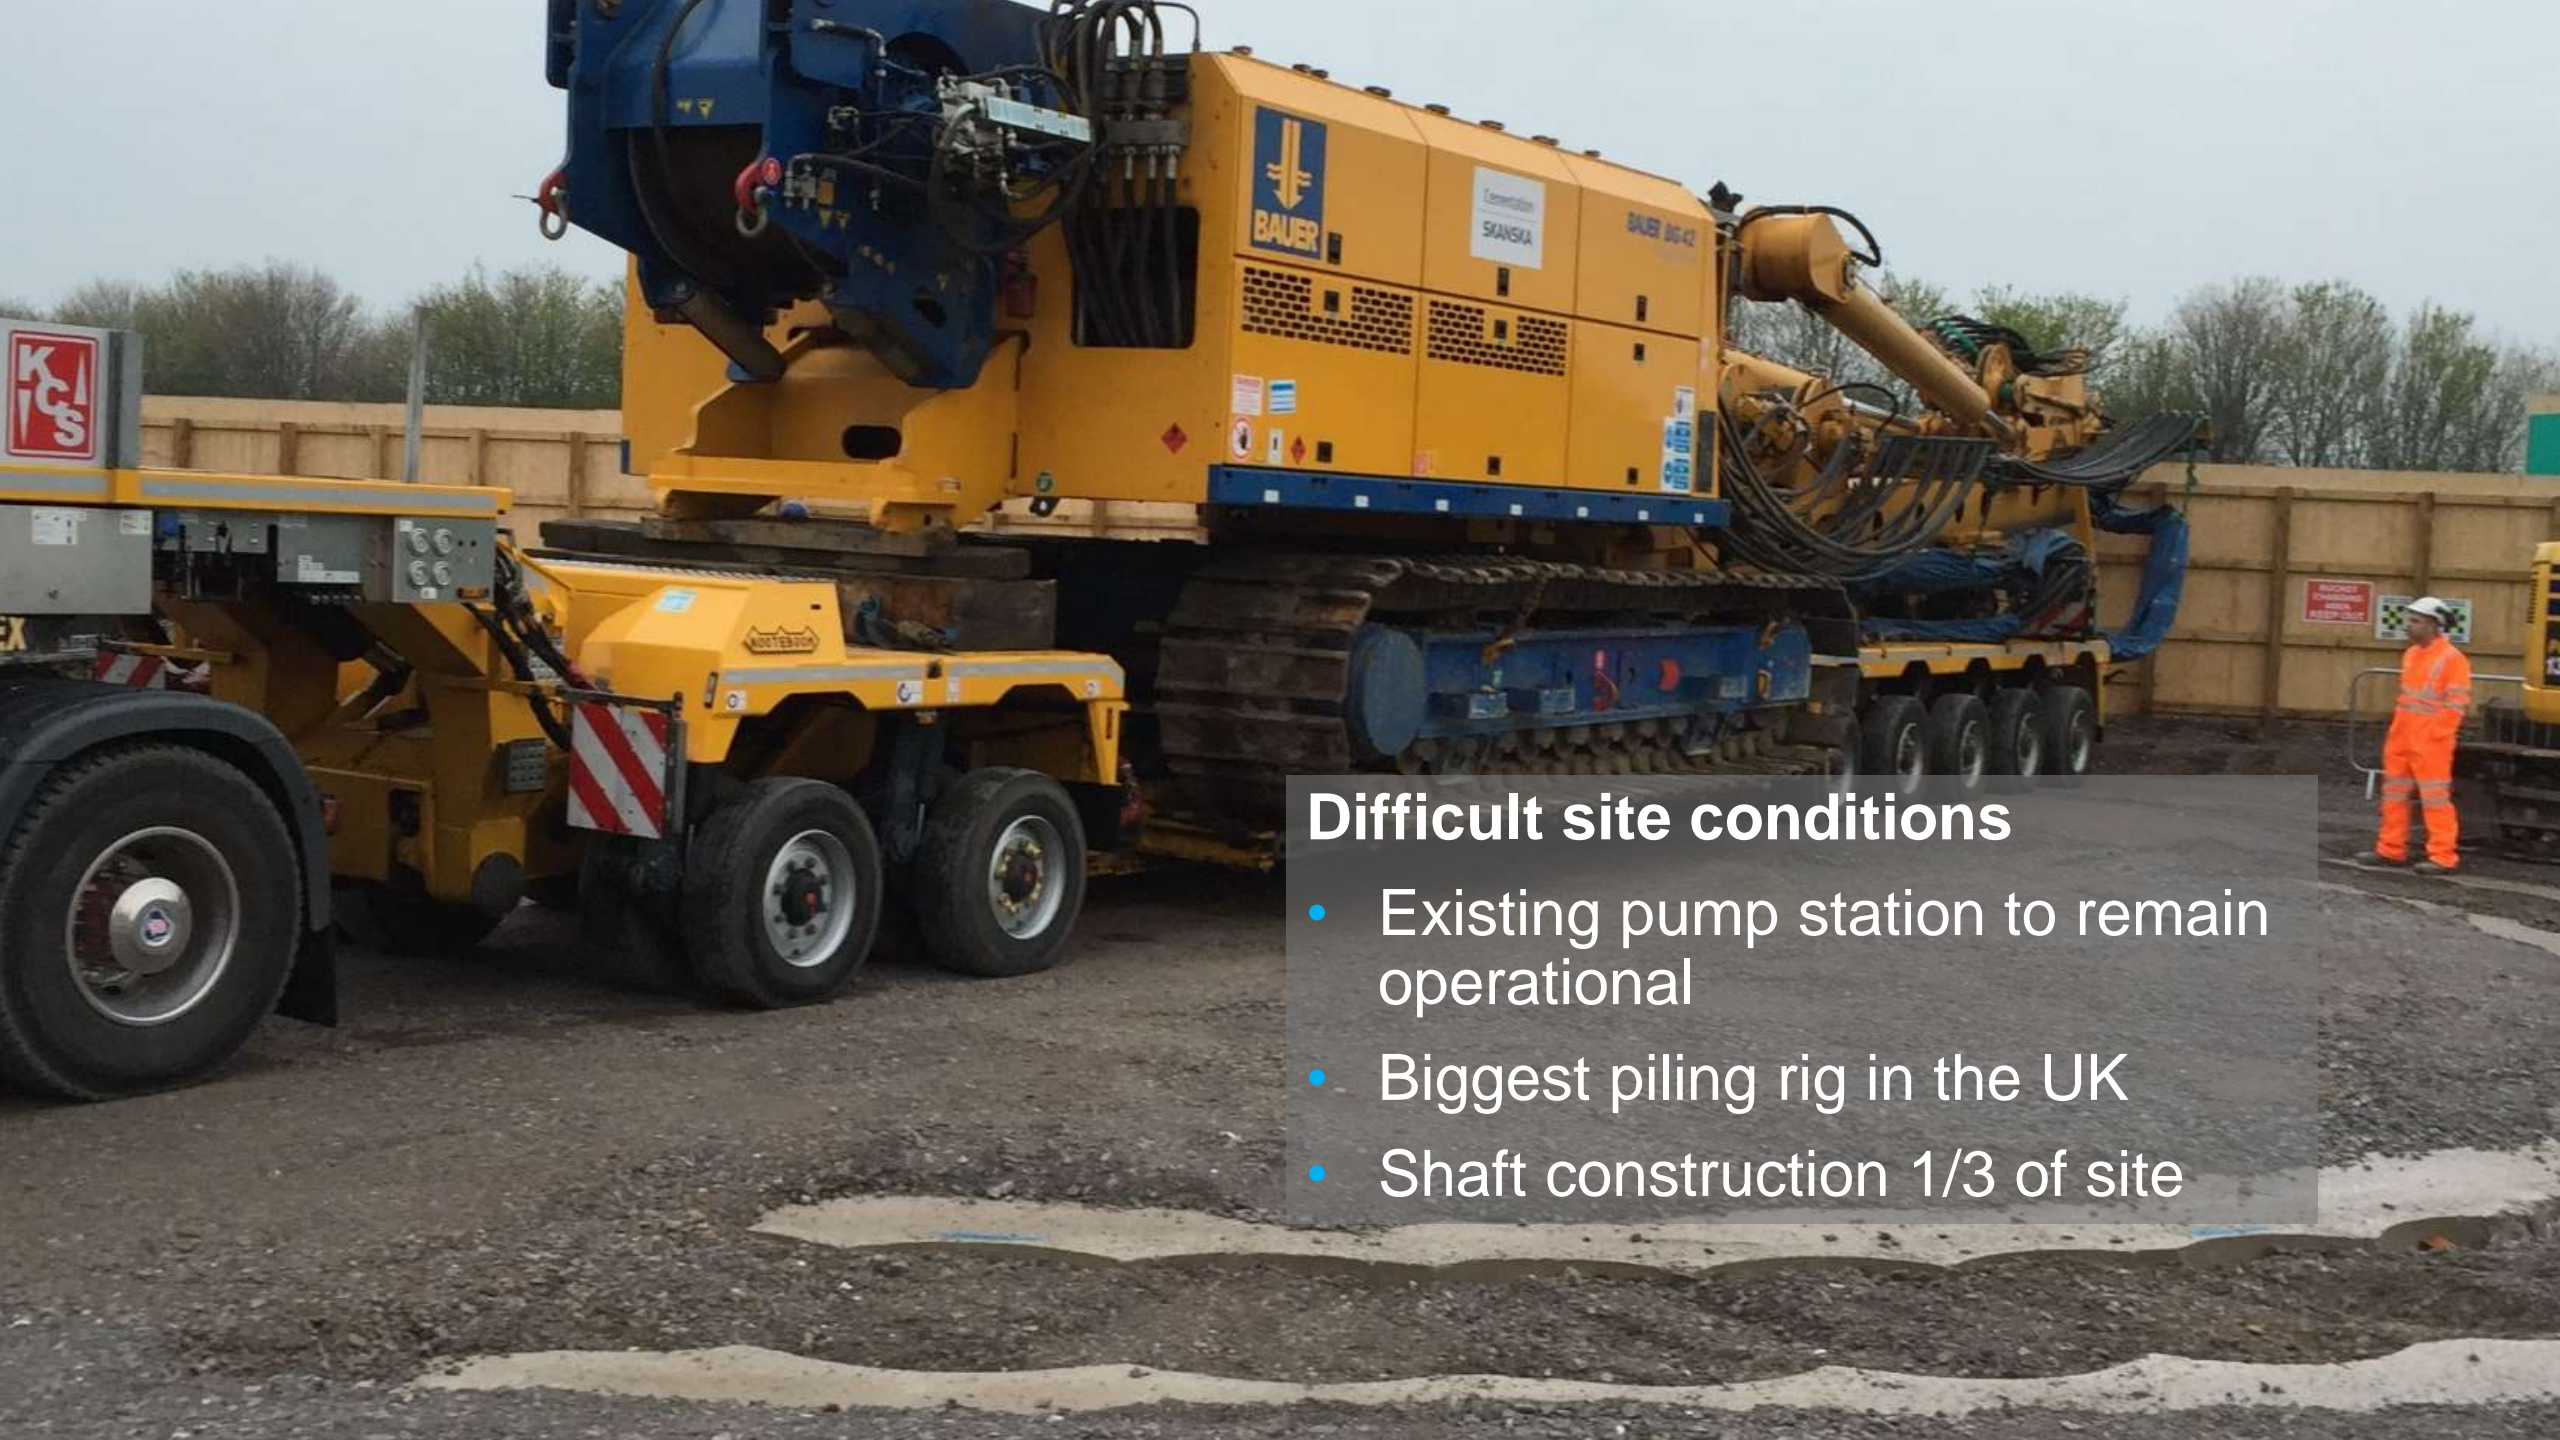
## Difficult ground conditions

- Poor ground
- High tidal water table
- Mercia mudstone  
~19 m deep
- Deepest unsupported secant piled shaft constructed in the UK

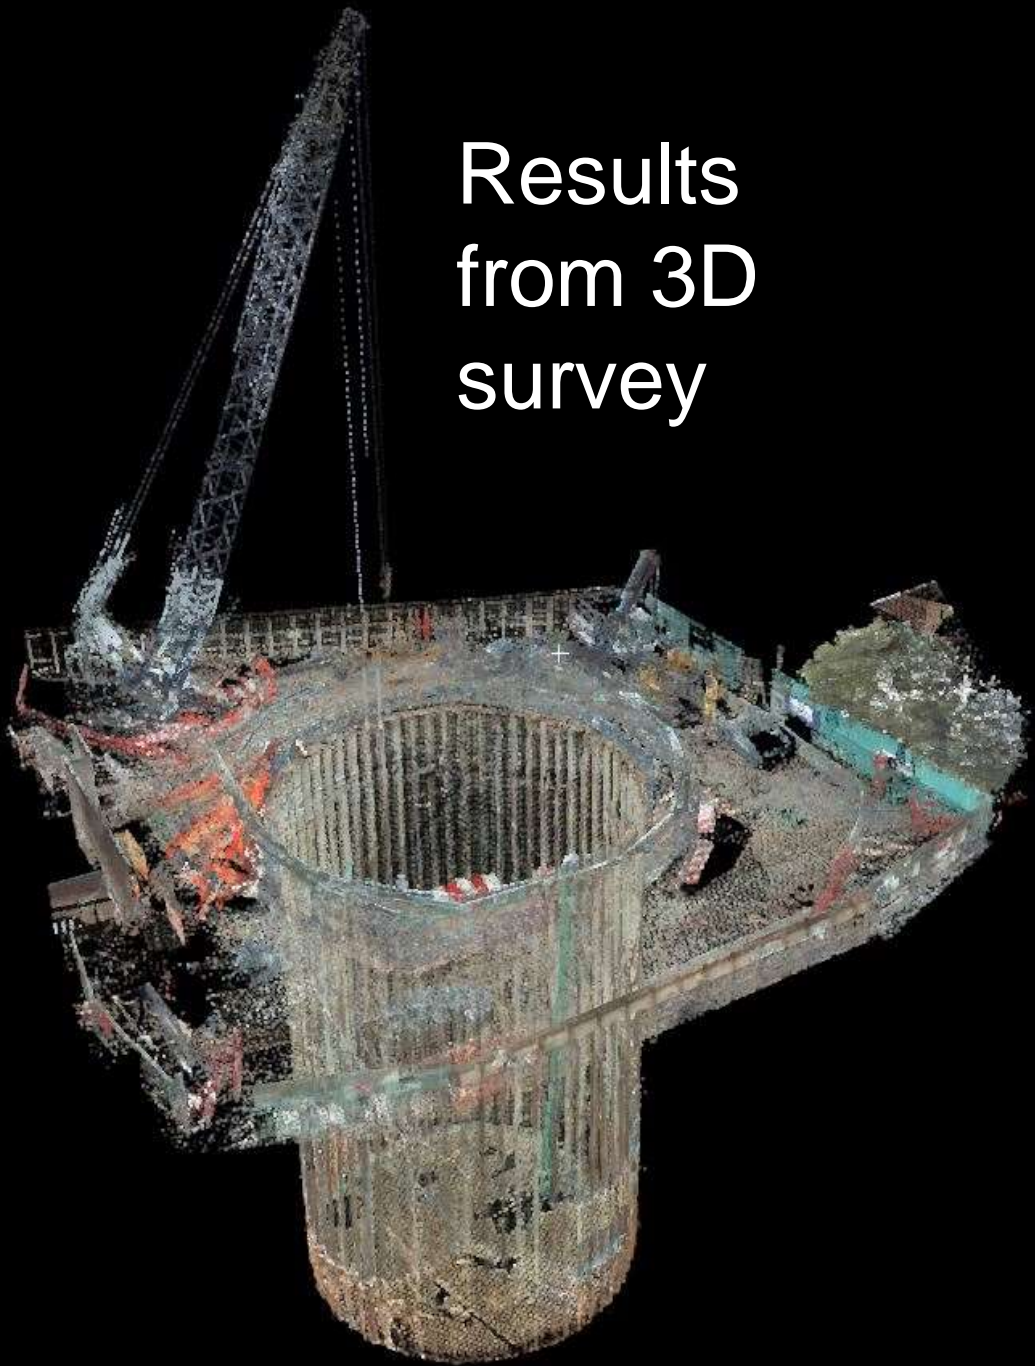
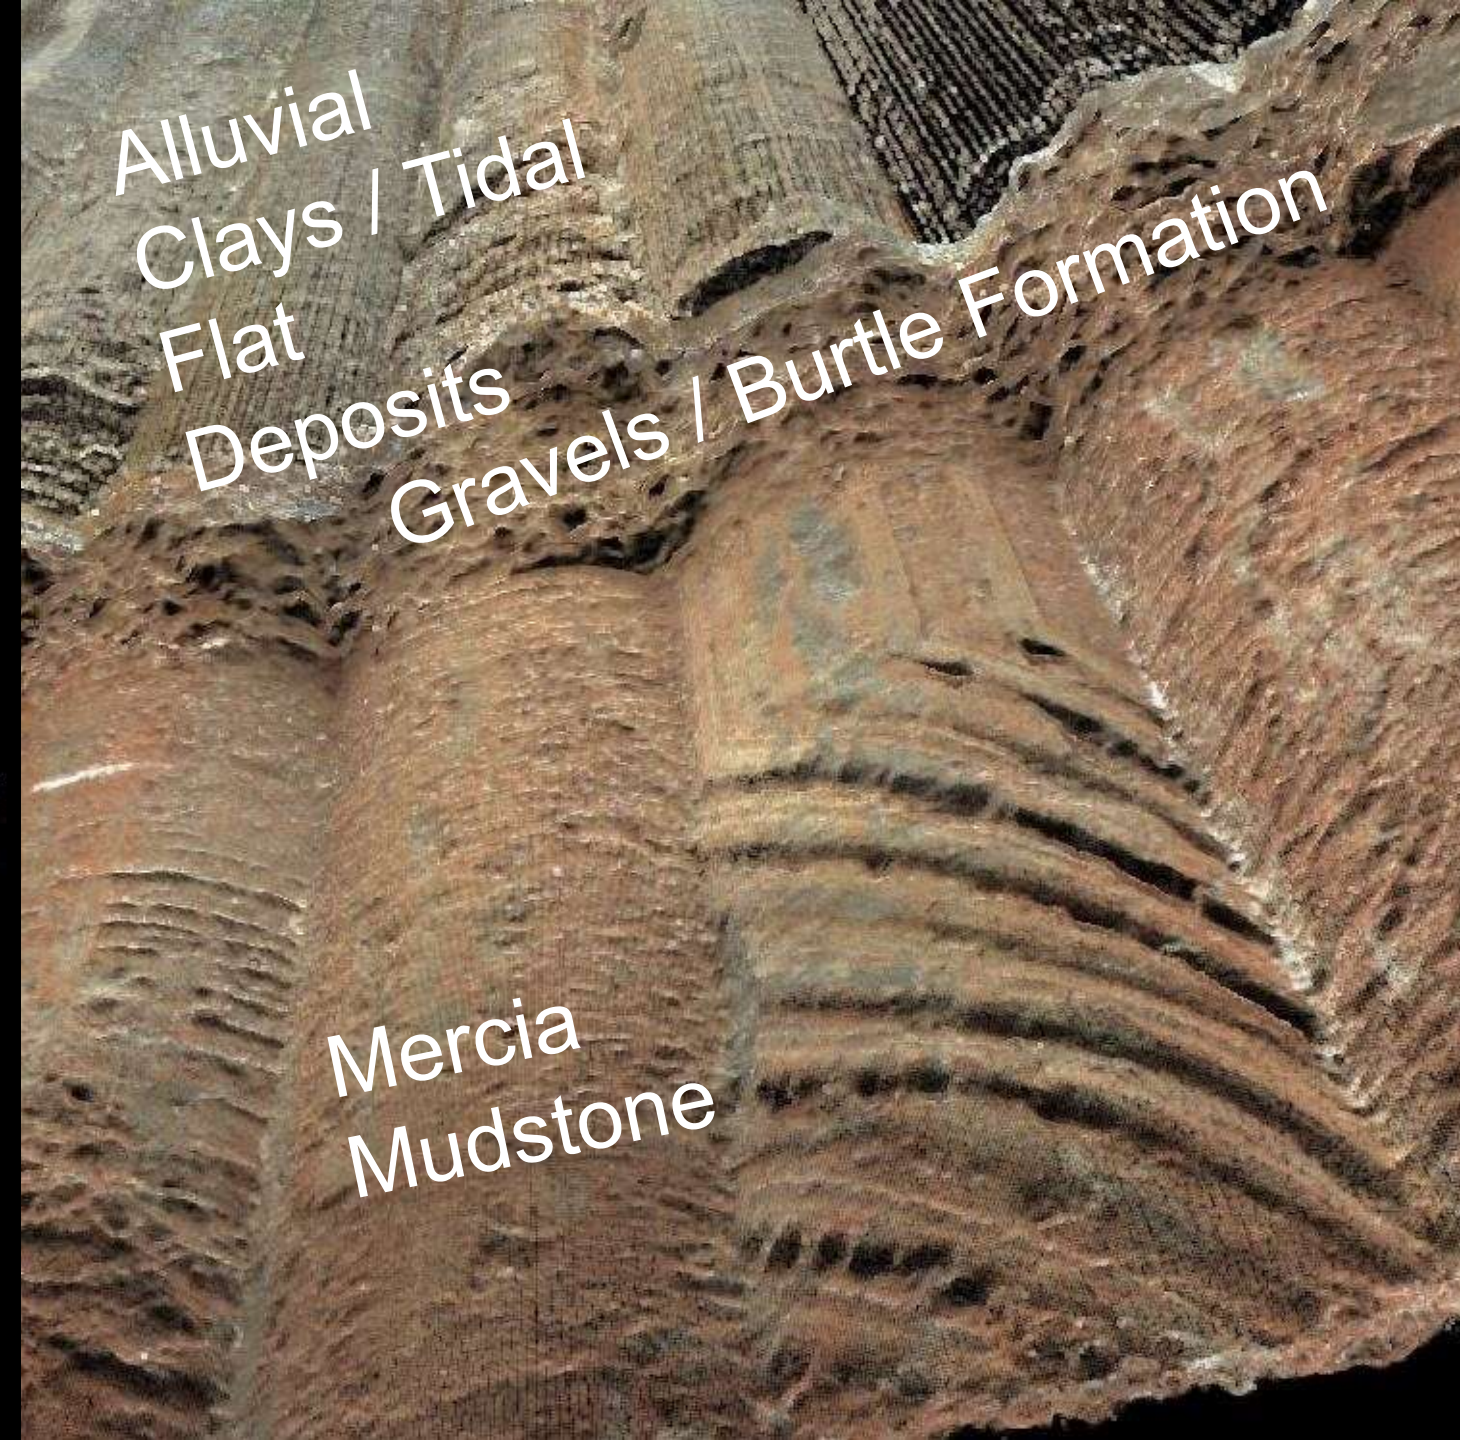
## Difficult site conditions

- Existing pump station to remain operational
- Biggest piling rig in the UK
- Shaft construction 1/3 of site

Results  
from 3D  
survey

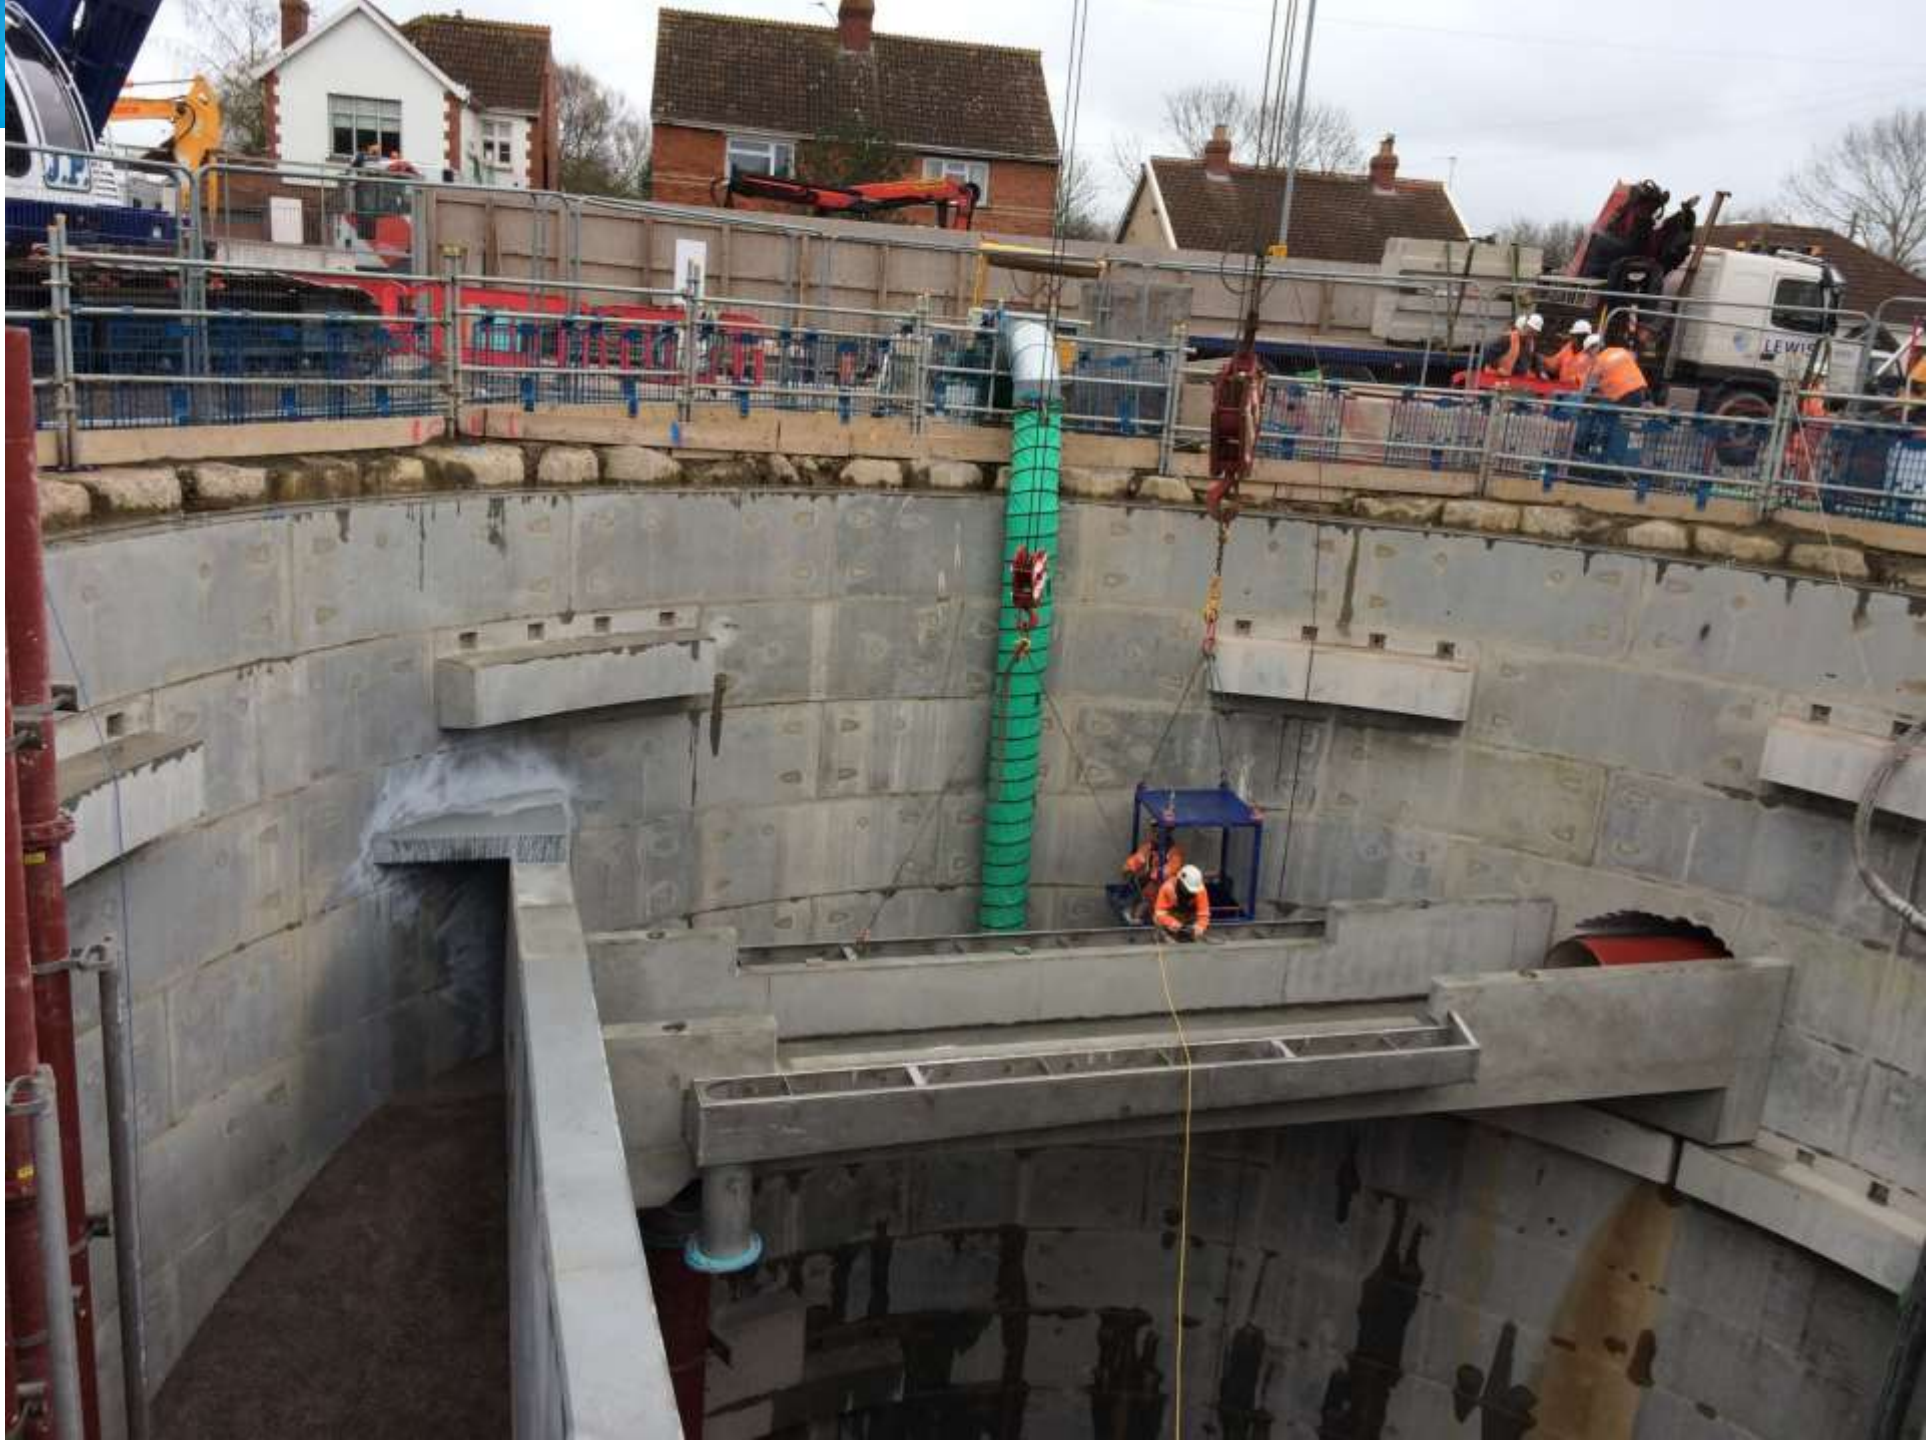
Alluvial  
Clays / Tidal  
Flat  
Deposits  
Gravels / Burtle Formation

Mercia  
Mudstone

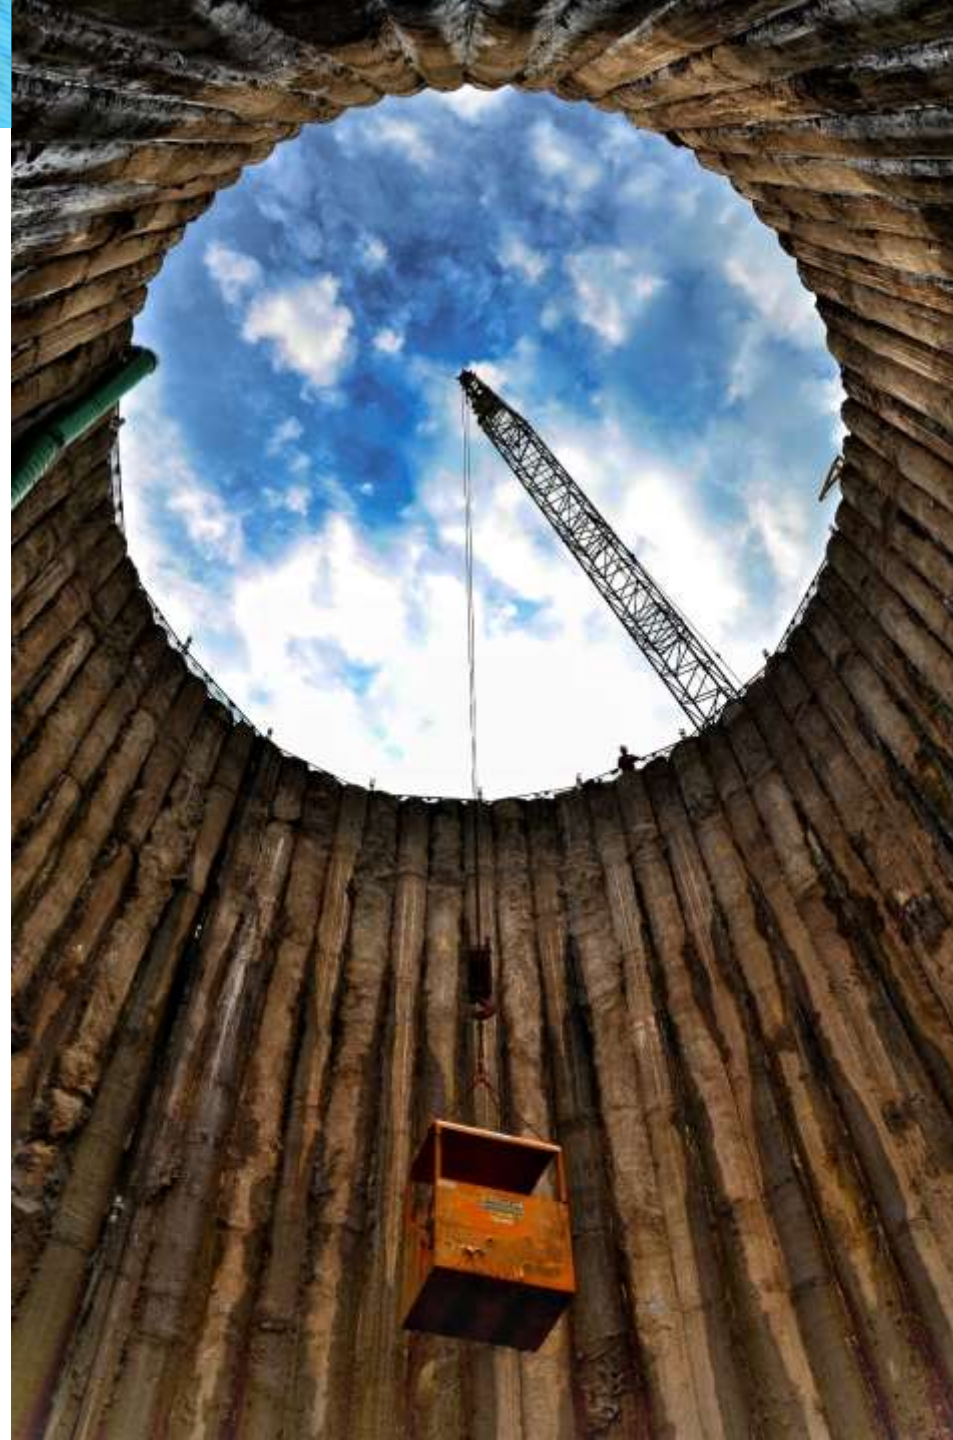
# Burnham Jetty overflow improvements

- Where we are providing storage we are future proofing the design

Scheme	Spills prior to works	Works	Spills post works
Bristol Road	21	3000 m <sup>3</sup>	1
Colley Lane	19	5000 m <sup>3</sup>	1
Sloway Lane	3	1200 m <sup>3</sup>	1
West Quay	16	2500 m <sup>3</sup>	1

\*Spills per bathing season

- Other improvements include:
  - Combining 2 treatment works and installing tertiary UV treatment
  - Increasing pass forward flows
  - UV disinfection of overflow

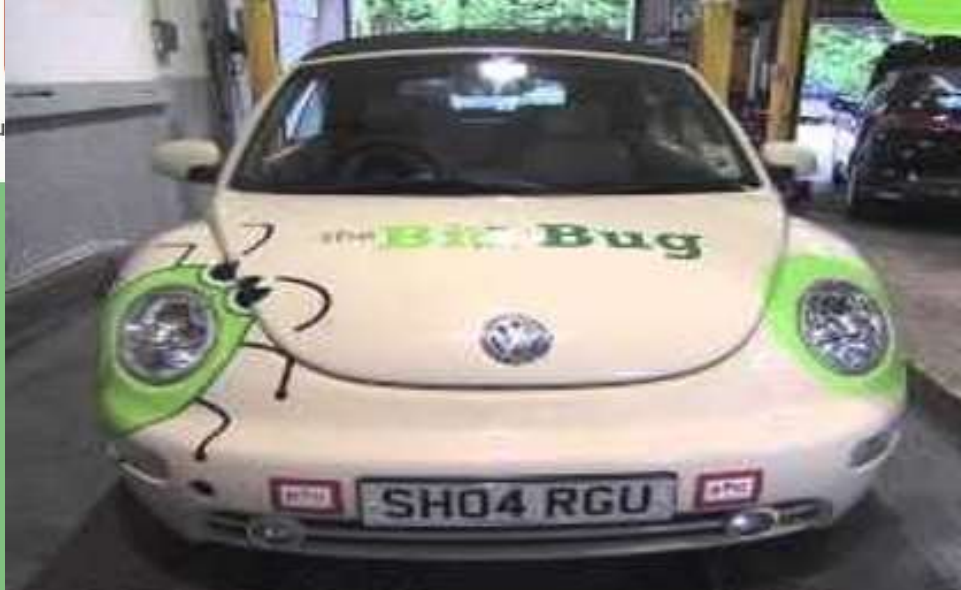
# Biomethane

Our facility in Avonmouth is a state of the art anaerobic digestion plant with depackaging capability. Renewable energy, in the form of electricity and **methane** is generated from the biogas produced in the digestion process, and the solid digestate is used as sustainable agricultural **biofertiliser**.
